DEVELOPMENT OF BIOTECHNICAL METHODS TO CONTROL SHORELINE EROSION

FINAL REPORT

Dr. D. A. Mays
Dr. K. R. Sistani

December 1, 1999

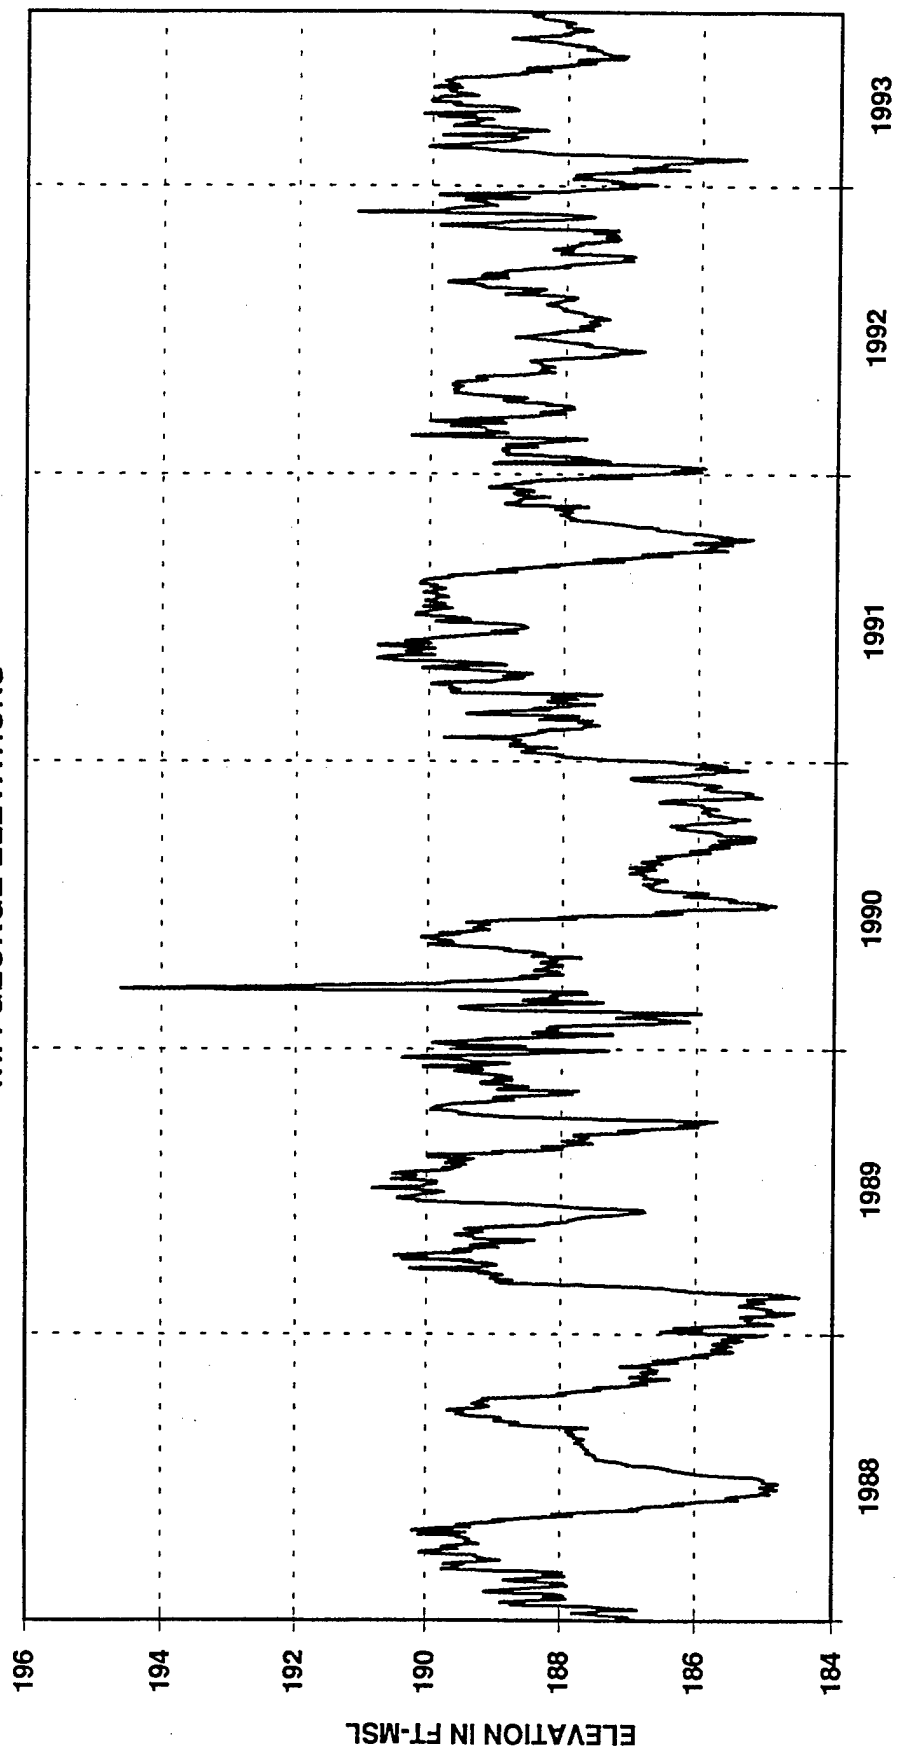
Typical fluctuations in lake elevations

W.F. GEORGE ELEVATIONS

Damage to private property has resulted because insufficient shoreline was purchased by the government before the lake was constructed. The water level in the lake varies from about 184.5 to 190 feet above sea level on a fairly regular basis because of navigation requirements and seasonal conditions. There is a navigation window about once a month at which time water is released from the lake to increase the depth of the Appalachicola River downstream to the minimum depth for barges. This results in a drop of several feet in the lake level. The level is then allowed to rise gradually until the next navigation window. Because of this fluctuation the lake is alternately at full pool with the waves lapping at the shoreline or has a dry beach as much as 40 or 50 feet in width. Almost all the erosion occurs when the lake is a full pool or above and the waves undercut the banks causing the soil to slough off into the water. The most severe wave action is due to winds blowing across the lake, however, boat wakes also cause some problems.

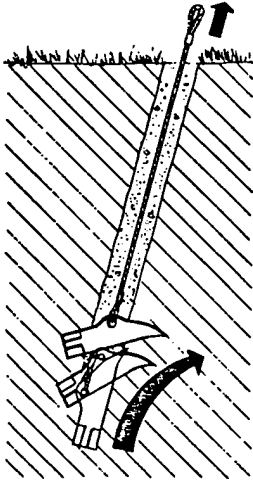
The Duckbill Anchor is driven into the soil using a hammer and drive rod. As the anchor is being driven it is actually compacting the soil around the anchor body. Once the anchor is to the proper depth the drive rod is removed. An upward pull on the cable rotates the anchor into load lock position. The anchor cuts into and further compacts the undisturbed soil. This method is far superior to conventional anchors that disturb the soil during installation.

Undisturbed soil

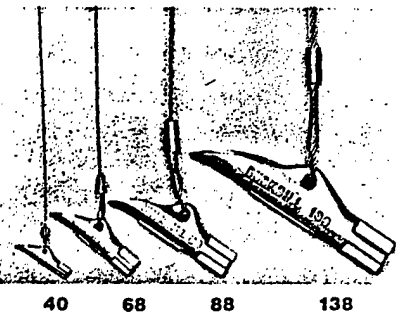
Specifications

Model Number	Holding Power In Normal Soil	Safety Factor Minimum Cable Breaking Strength	² Galvanized Steel Cable	Cable Length	Anchor Weight	Standard Pak And Weight
40-DB1	300 lbs.	480 lbs	1/16" 7 x 7 GAC	20"	1 oz.	50/box 3.7 lbs.
68-DB1	1,100 lbs.	1,700 lbs.	1/8" 7 x 7 GAC	2 1/2 ft.	4.5 oz.	24/box 7 lbs.
88-DB1	3,000 lbs.	7,000 lbs.	1/4" 7 x 19 GAC	3 1/2 ft.	14 oz.	12/box 11 lbs.
138-DB1	5,000 lbs.	9,800 lbs.	5/16" 7 x 19 GAC	5 ft.	2.5 lbs.	12/box 32 lbs.

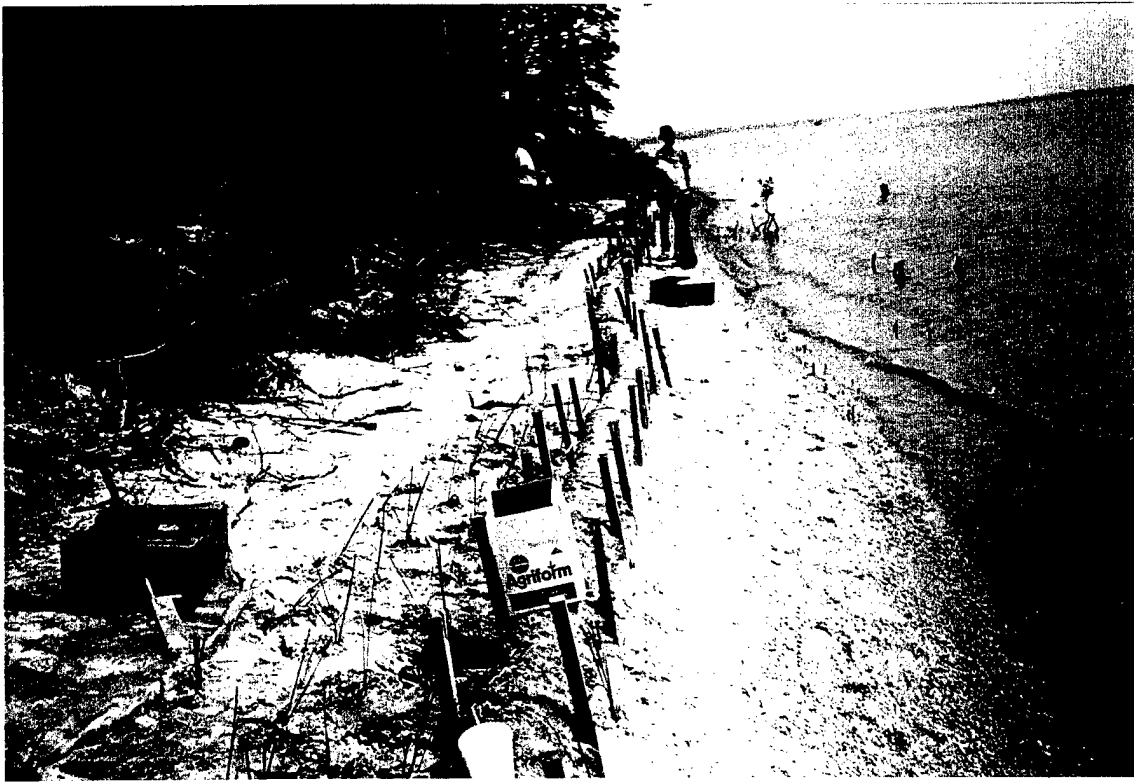
12 inch coconut fiber log breakwater.

Coconut fiber (coir) logs which were 10 feet long and 1 foot in diameter were compared with wheat straw bales (14 inches x 18 inches by 3 feet) wrapped in poultry netting to provide protection from wave action. These breakwater materials were placed at an elevation of 189 feet in sections of 100 feet of each material replicated 3 times. We placed an additional 150 feet of straw bales at one end. Thus, approximately 750 feet of shoreline was treated. Both the coconut fiber logs and straw bales were secured in place with 3-foot wooden stakes placed 2 feet apart on each side then wired together on top of the breakwater material.

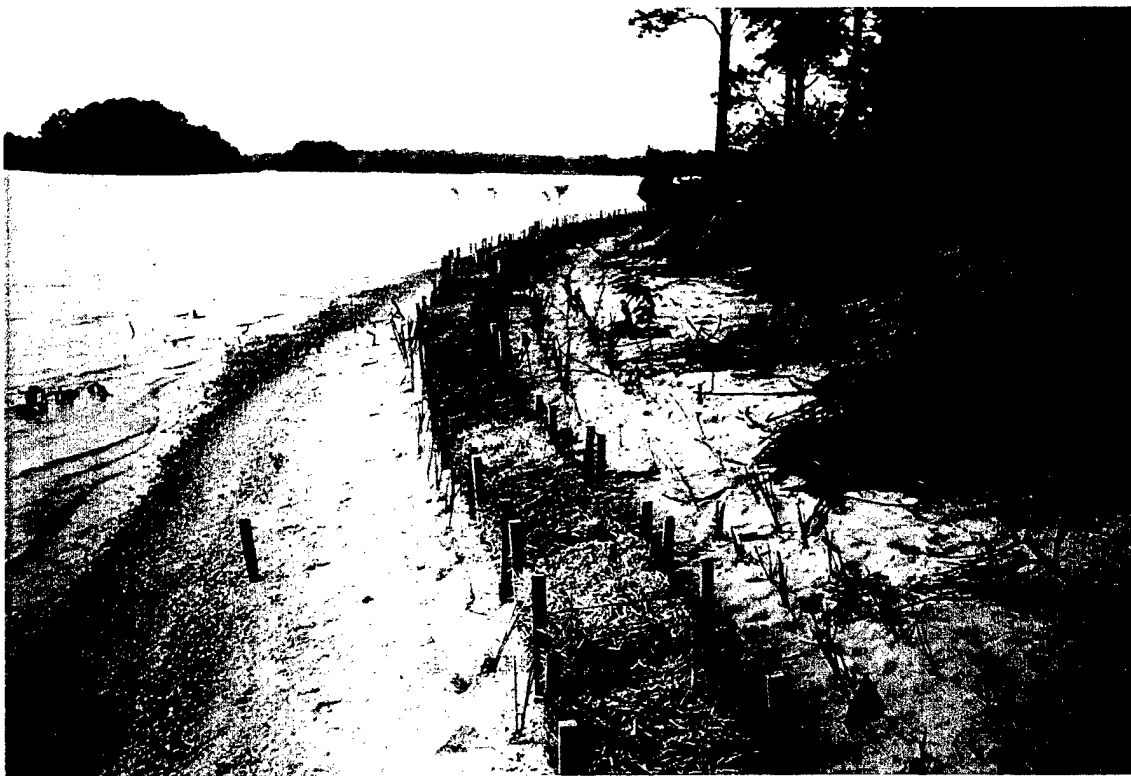
Chicken wire wrapped straw bale breakwater.

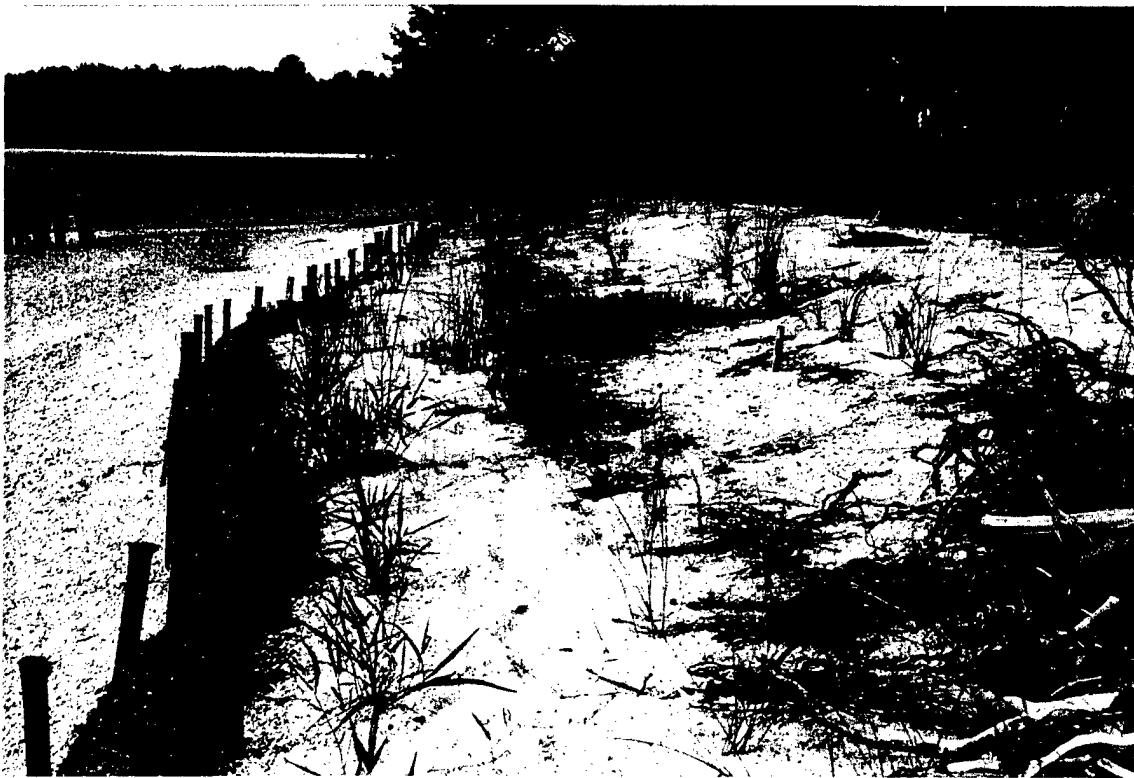
Vegetation growing behind breakwater.

When the water receded enough for a good visual assessment of the situation, we found that sand and silt had been deposited behind the coconut fiber logs and wire wrapped straw bales to essentially the full depth of these breakwater structures. This deposited material had completely covered the plants set in May resulting in 100 percent stand loss, however it resulted in about one foot of soft, easily planted substrate.

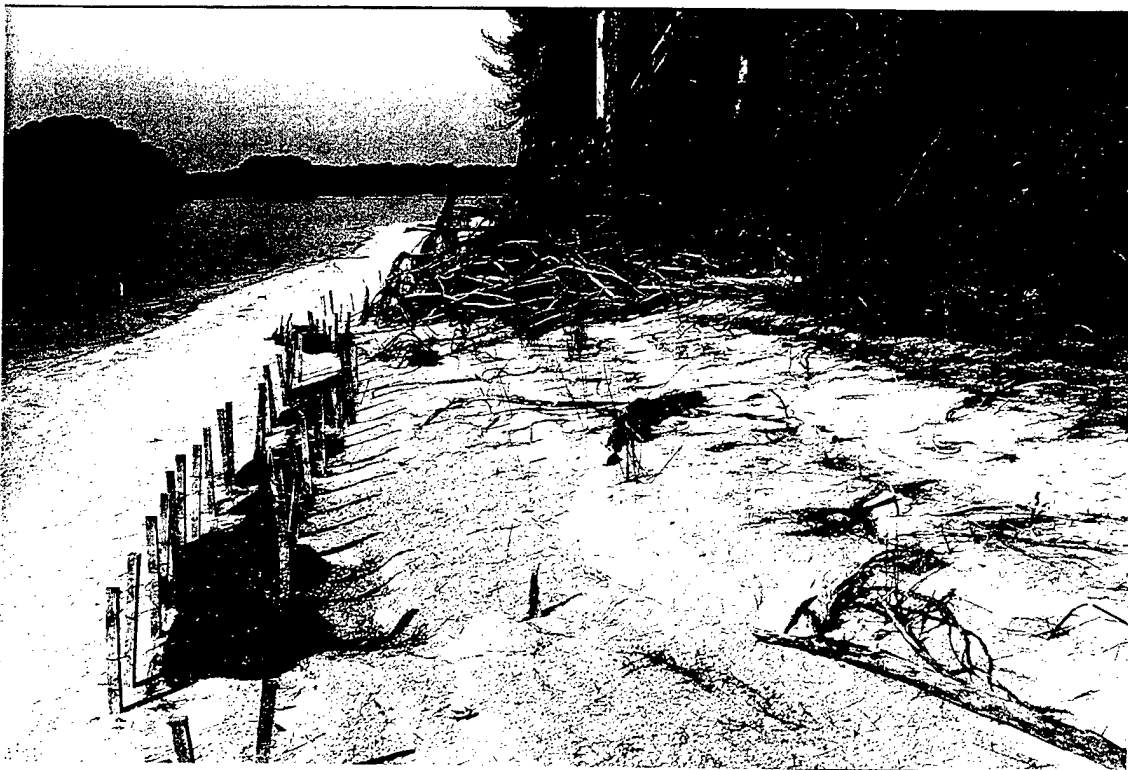
Storm associated with Gulf Coast hurricane destroyed breakwater and vegetation.

In the spring of 1995 the sandy area behind the breakwater was again replanted with *Spartina patens* and *Spartina bakeri*. These plants became established and grew well throughout the 1995 growing season. The area was pounded by a hurricane in September 1995. While the plants sustained some damage, many survived. This event, however, destroyed the wire wrapped straw bales.

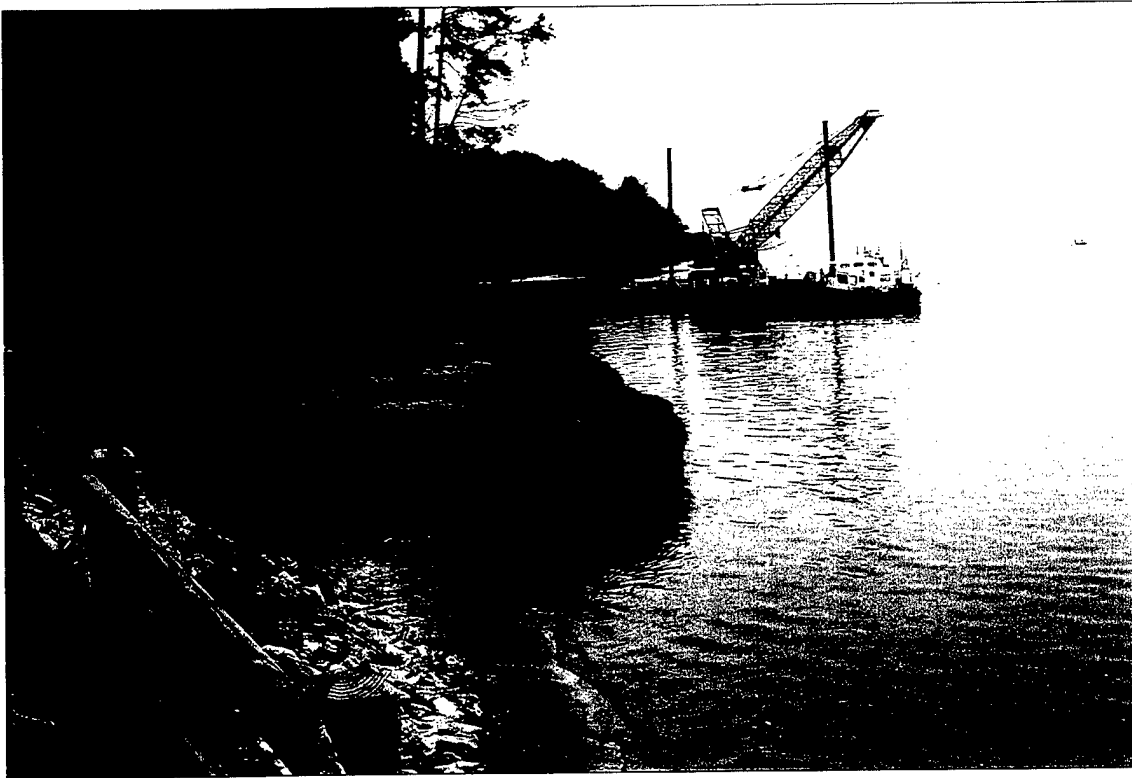
Large round hay bales placed as a breakwater.

Eighty bales weighing 1000 to 1200 lbs each were placed in a row on the shoreline at an elevation of approximately 187 feet in December 1994. This created a protected area

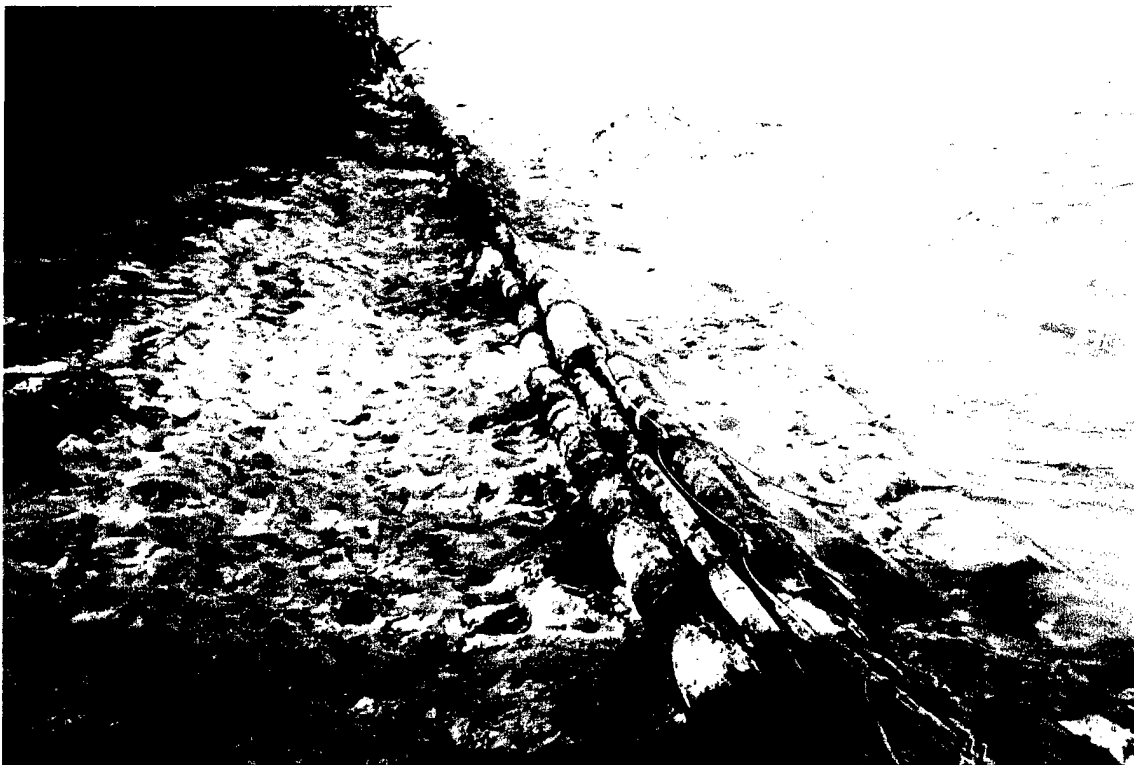
Pine logs cabled together and anchored with
Duck BillTM anchors.

The breakwater was centered at approximately the full pool level (189 ft) and built about 1.5 ft in height. After the logs were placed they were wrapped with 1/4 inch steel cable at 4 ft intervals. The wrapping cables were also run through the eye of cables on Duck Bill™ anchors which were driven to a depth of 3 ft. A 0.5 inch steel cable was anchored to a tree at each end of the breakwater and fastened to each wrapping cable along the length of the breakwater. All cable fastenings were accomplished with the use of U-bolt cable clamps. The breakwater was 300 feet long. At the time of construction we planned to wait 3 to 6 months for sand and silt to accumulate behind the breakwater to the height of the breakwater before establishing vegetation.

While the completed breakwater appeared to be well secured, it was destroyed by wave action within 2 or 3 months. An inspection of the site revealed that no anchors were pulled loose and none of the cable connections failed. The logs appeared to have slipped out of the wrapping cable loops in a lengthwise manner due to severe wave action during the spring. When we inspected the site in May the structure was more than 50% destroyed.

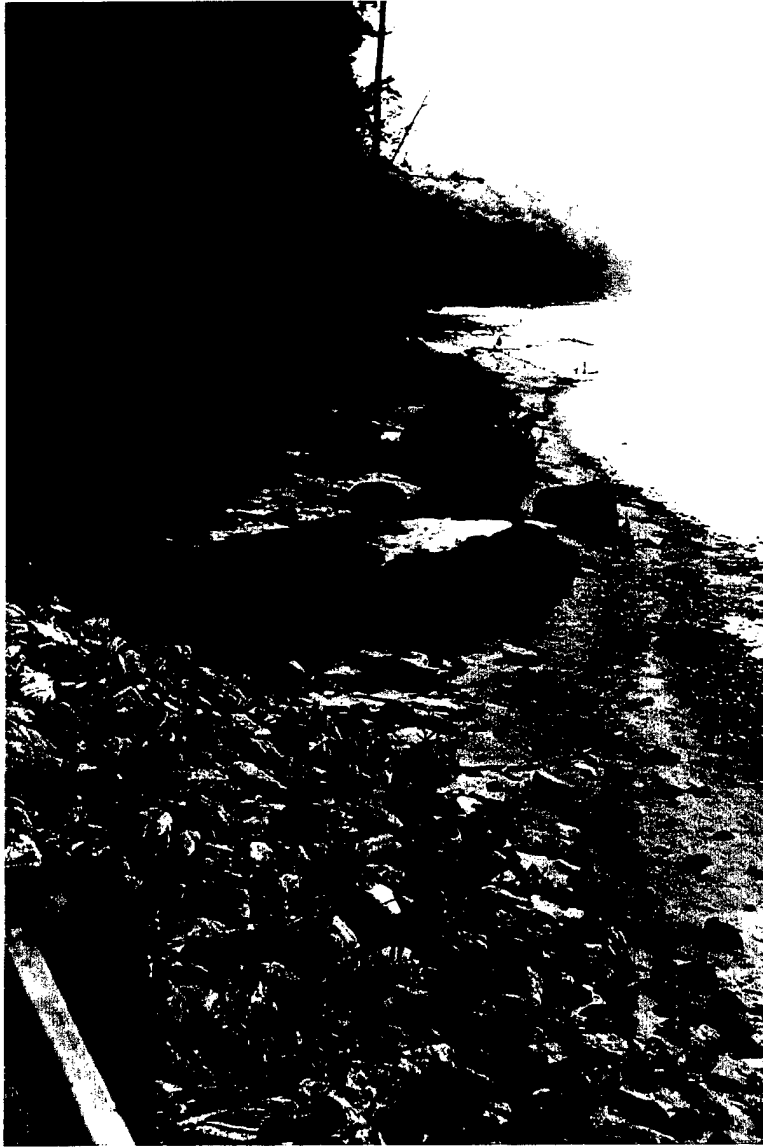
Hay bale breakwater was destroyed by flooding.

The January 1995 high water episode described above was also responsible for destroying this installation. The lake level rose above the tops of the bales and caused them to float out into the lake. Since this was thought to be an isolated incident the Corps of Engineers personnel salvaged enough of the bales to create a new breakwater about 200 feet in length, however, within a few months the waves destroyed this also.

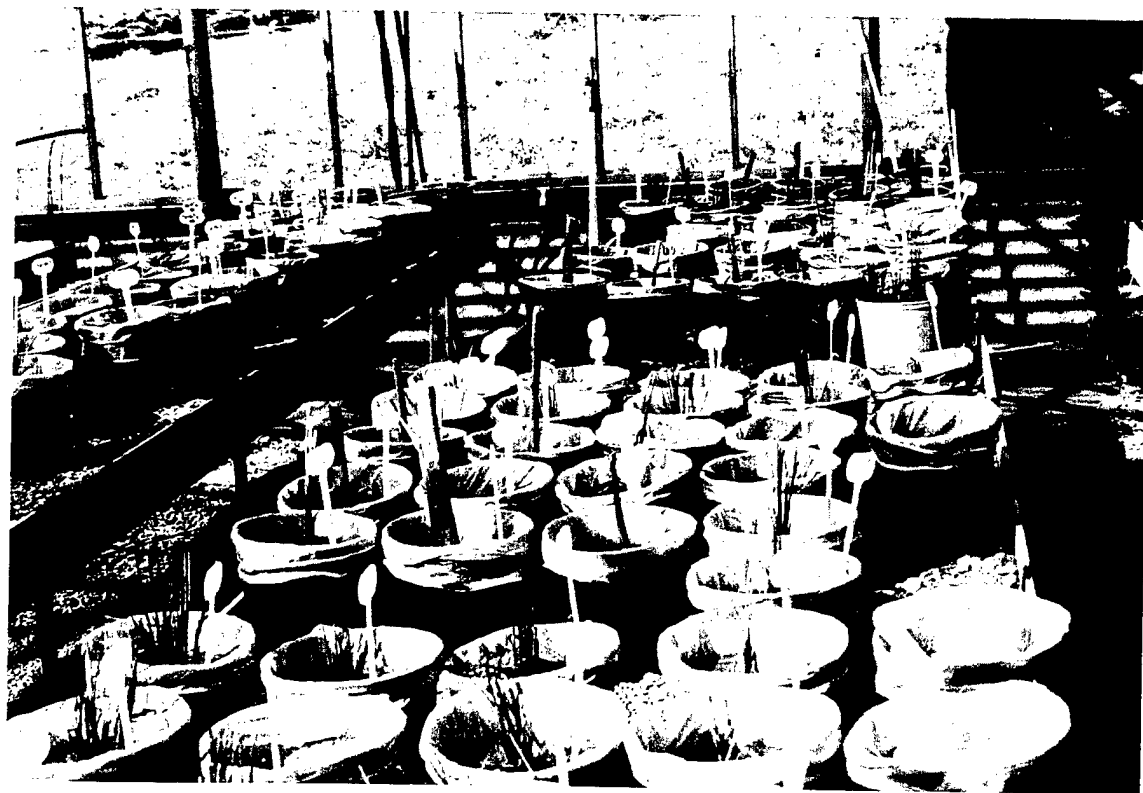
Newly planted wetland plants.

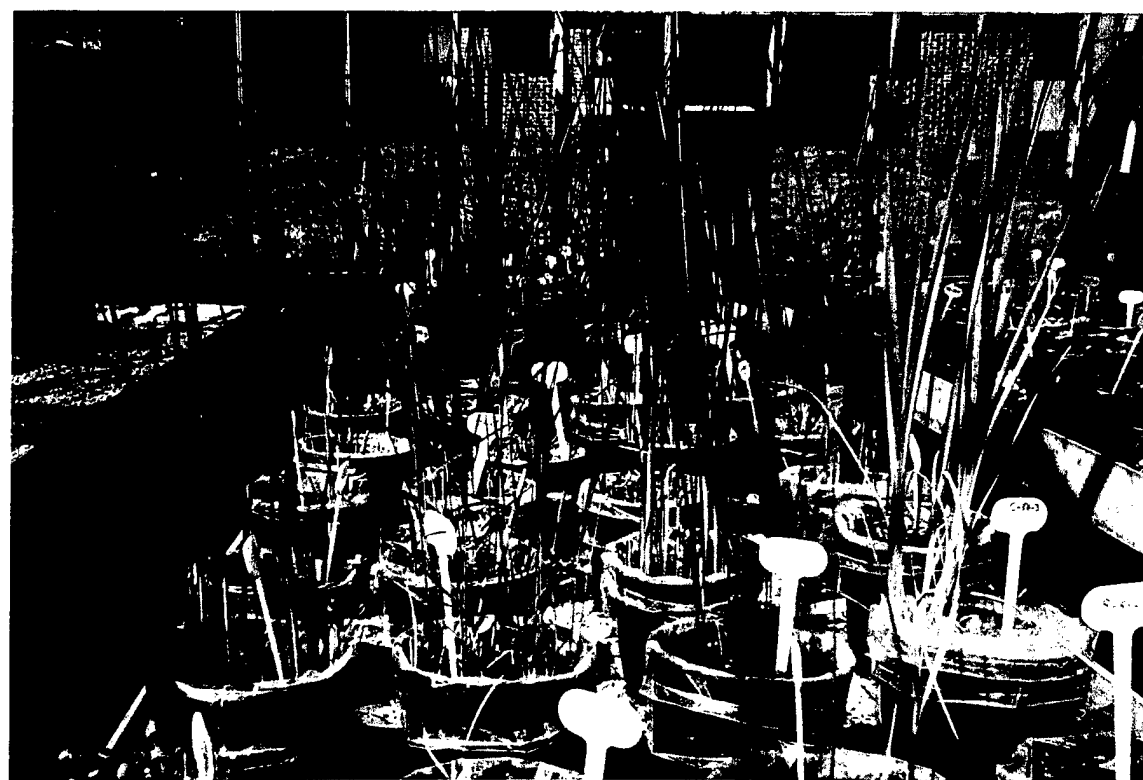
Wetland plants ready for harvest.
